LANDMARKS AND HISTORIC
PRESERVATION COMMISSION
AGENDA
SEPTEMBER 7, 2021

2021 DOWNTOWN HISTORIC DISTRICT RESURVEY CITY OF MEDFORD

SUBMITTED BY: ADAPTIVE PRESERVATION, LLC

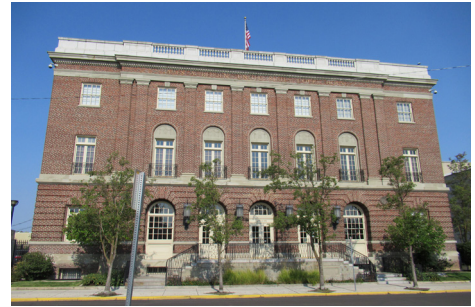
- Applies to properties that retain excellent architectural integrity and clearly represent associations with the established historic context(s). A property that independently meets the National Register Criteria for evaluation can also be contributing to a historic district if it falls within the district boundaries and has associations with the district’s areas of significance. (Example: 310 6th Street West, US Post Office Courthouse Building)

310 6th Street West: Eligible Significant

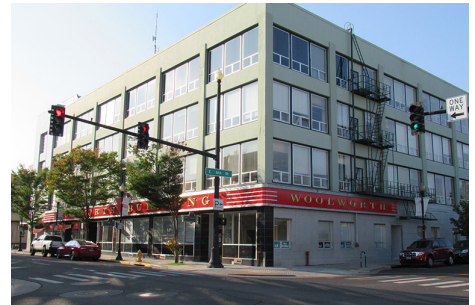
- Applies to properties that do not retain sufficient integrity or associations to merit individual listing but would enhance the historic associations and the architectural qualities of a historic district.
- Contributing properties do not have to be individually distinctive, but must contribute to a grouping that achieves significance as a whole. The majority of the components that define a district’s historic character must possess integrity, as must the district as a whole.
- Contributing buildings typically have “Excellent” or “Good” integrity, although there may be occasions where resources with “Fair” integrity are contributing.

29 Central Ave N: Eligible Contributing

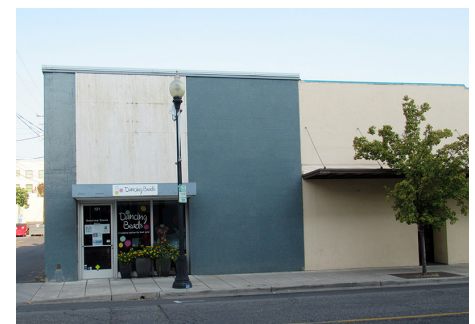
- Applies to individual properties located within a historic district that have lost their historical integrity, were not present during the period of significance or do not relate to the documented significance of the district.
- Properties with non-historic siding were considered to be non-contributing, despite associations with proposed areas of significance. Properties with non-historic siding should be re-evaluated for register eligibility if and when the non-historic siding is removed.

121 6th Street E: Non-Contributing

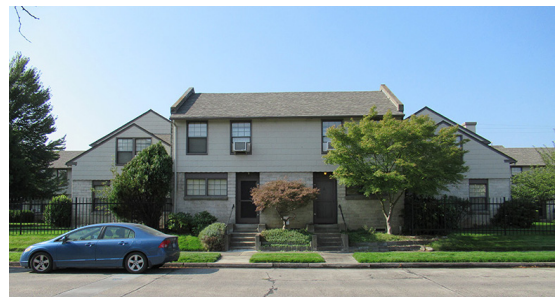
101-151 Ivy Street: Evelyn Apartments

During World War II, Medford experienced an unprecedented period of growth and economic activity. Supported by the massive investment of the federal government for the construction of Camp White, Medford's downtown became the focal point for the recreation activities of the almost 40,000 military personnel stationed at the base. During construction, an estimated 10,000 workers flooded the area, working round-the-clock as the new military camp was rushed to completion in just eight months. Later more than 9,000 civilians found work at Camp White as support staff all created increased pressures on the local residential market, with garages, barns, chicken coops and other structures all being rapidly converted to housing uses. Within the downtown district, single family residences were converted to apartment or multi-room usage. Typical is the conversion of many of the homes along North Ivy and Holly streets (For example, 235 Ivy Street and 221 Holly Street), A special case of war-inspired construction is the Evelyn Apartments (101-151 Ivy Street) which were built under special authority during the war as housing.

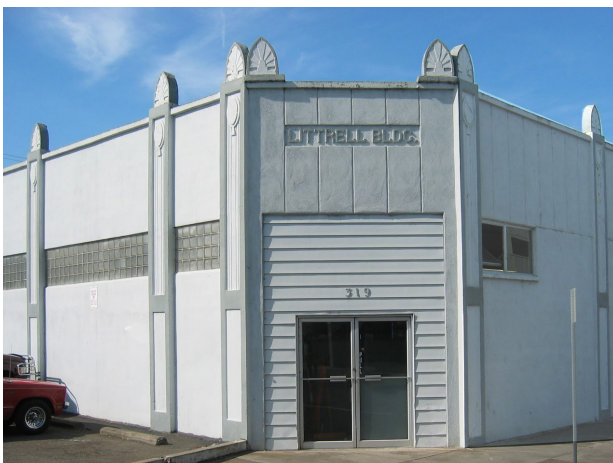
When the Littrell Building at 313-319 6th Street was demolished for adjacent redevelopment and park blocks, special care was taken to keep the buildings finials and incorporate them into the landscape in the new Pear Blossom Park. This is an excellent example of way to utilize historic architectural details in a unique manner that is both interpretive and publicly accessible. When future redevelopment occurs and if historic structures are compromised or demolished, Adaptive Preservation recommends the City encourage public and private developers to gift these historic architectural elements to the City for continued public use and historic storytelling.

Littrell Building Prior to Demolition
Photo Courtesy: The Preserve Oregon Blog

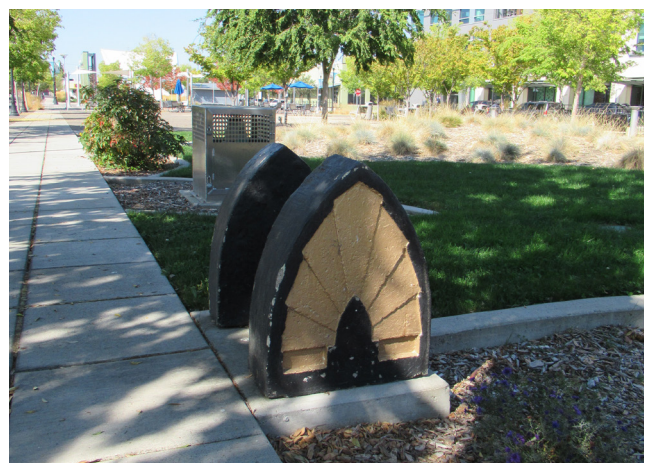
Finials from Littrell Building Placed in Pear Blossom Park
